Damage to Grier St. POC [Br. #53-1158] Post-Earthquake Investigation Team Report

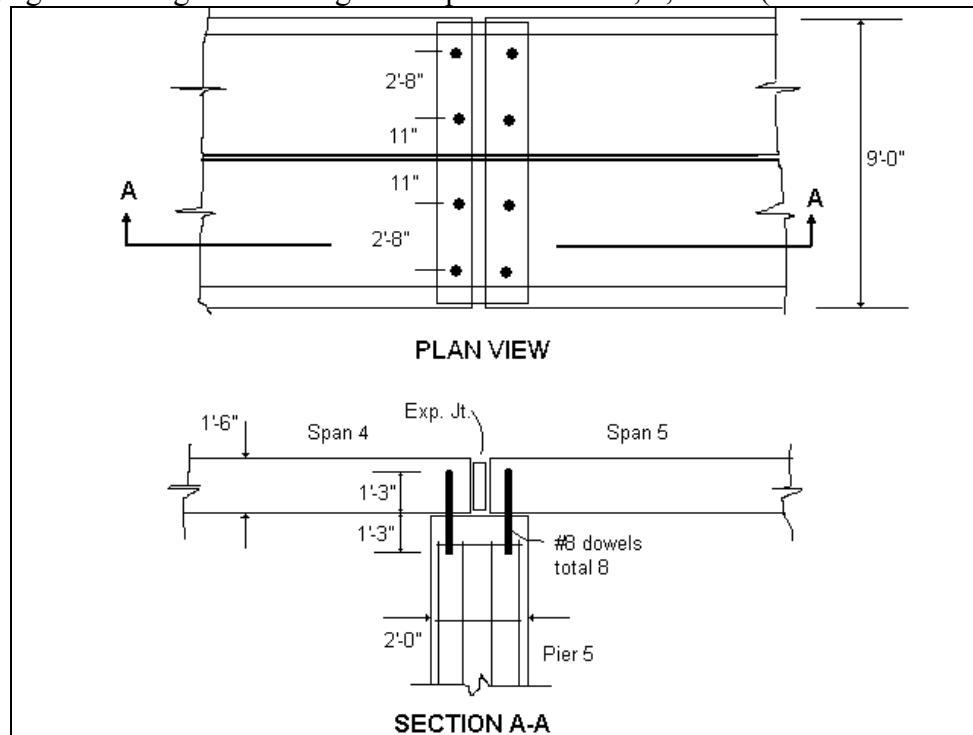
The Grier St. POC is located at Post Mile 1.2 on Route 71 in Los Angeles County in the city of Pomona. This bridge is a simply supported eight span precast prestressed voided slab pedestrian overcrossing bridge. The precast slabs (two 4 ft. wide slabs placed side by side) are supported on rectangular reinforced concrete pier bents and seat type abutments. The top of the pier is only two feet wide, and this seat is shared by adjacent spans, making the seat width slightly less than one foot (Figure 3). The two precast slabs are doweled and grouted to the piers with 2 - # 8 bars each (total of four grouted dowels at each end of a span) at both supporting piers (Pier 4 and Pier 5). The precast slabs are

Figure 3 Support Connection at Pier 5.

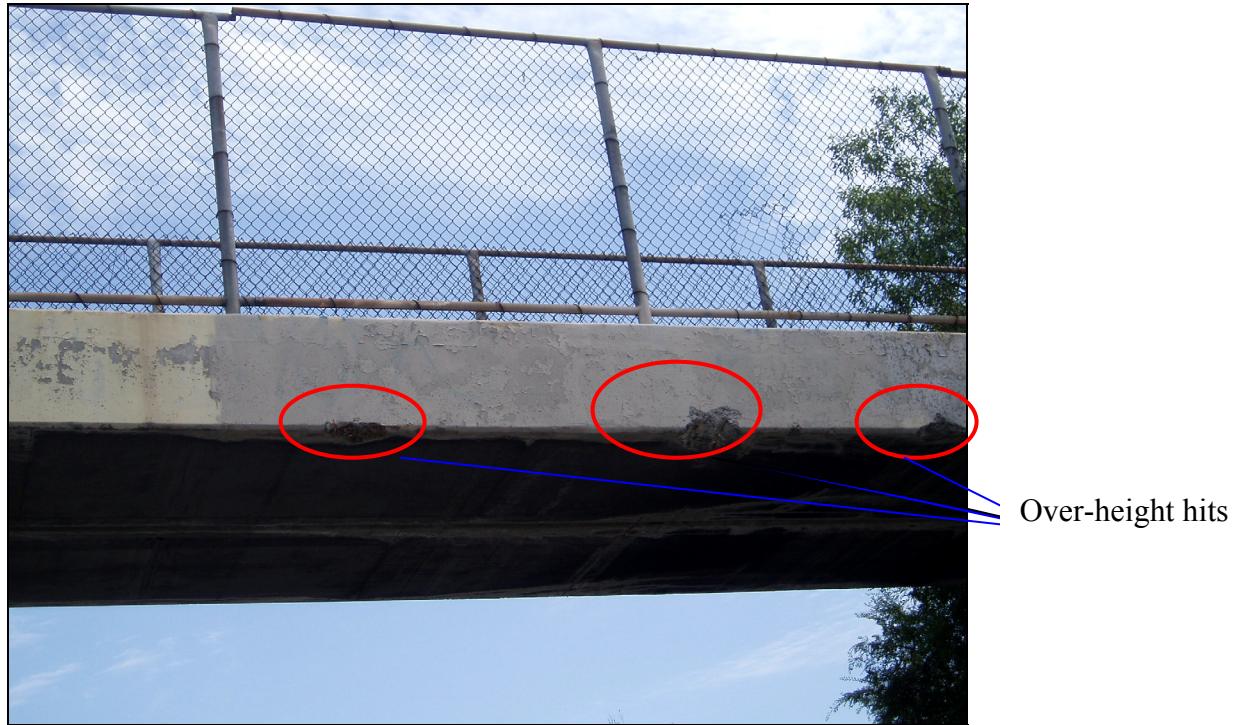
- C. BIR 8/20/2004:
Records showed the structure appears to be in good condition.
- D. BIR 8/16/2007:
Records showed numerous over-height hit spalls over the NB lane (Span 5). The report did not mention the three pocket spalls on Span 4 (SB lane), as shown in Figure 4 (taken on 8/4/2008). In addition, the bridge has been identified as one of the bridges requiring work to comply with the Americans with Disabilities Act (ADA) requirements. Note that the earlier contract to widen the northern segment of Route 71 wherein this POC was to be removed (EA 07-21060) was never completed, and thus the POC remains in service.

Figure 4 Damage to superstructure from over-height hits in Span 4

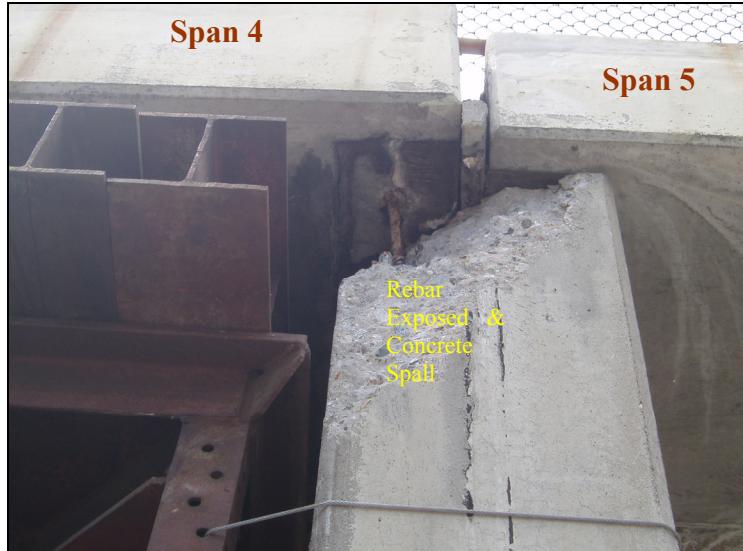
Concrete spalled at both ends of the top of Pier 5 supporting the Span 4 slab, exposing one dowel at each side. The two exterior dowels at each end of the are bent and the Span 4 slab exhibited a permanent transverse displacement of about 3 to 4 inches (toward the Southeast direction), as shown in Figure 5.

Figure 5 Concrete spalls at the southwest corner of Pier 5; note the evidence of corrosion on the dowel connecting the superstructure voided slab to the pier

The extent of transverse displacement at the piers does not seem to affect the overall structural stability, and no imminent collapse is anticipated at this time. The structure is currently closed. In addition, Span 4 is supported with temporary falsework at Pier 5.

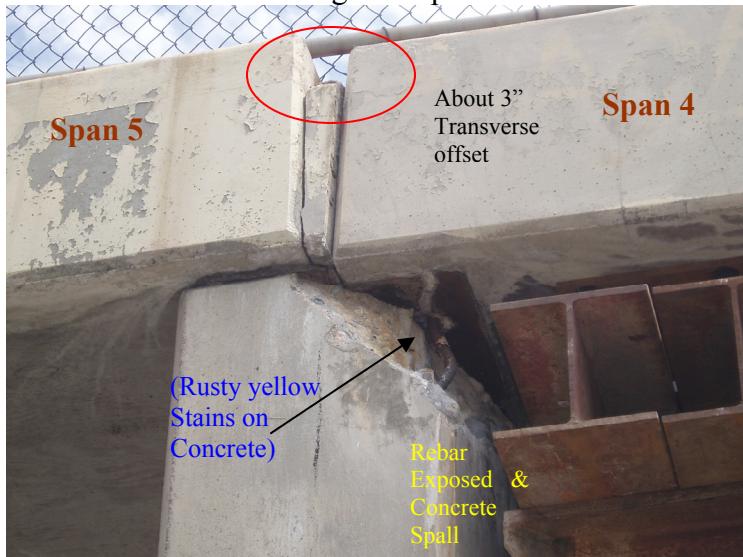
The exposed spalled area of concrete at the Northwest end of the Pier 5 seat exhibits rusty yellow stains (Figure 6). The exposed stains indicate that the area was cracked prior to the Chino Hills Earthquake. In addition, rust was observed on the two exterior dowels, which are now bent. The previous concrete cracking at the top edges of the Pier 5 may be related to the truck over-height hits on the Span 4 slab.

Figure 6 Concrete spalls and stains at the northwest corner of Pier 5 (note stains).

- It is theorized that previous over-height truck hits on Span 4 may have induced cracks at the top of Pier 5. The ground motions from the Chino Hills Earthquake on 7/30/2008 placed further demands on the weakened connection, spalling the concrete and resulting in the bending of the connection dowels.

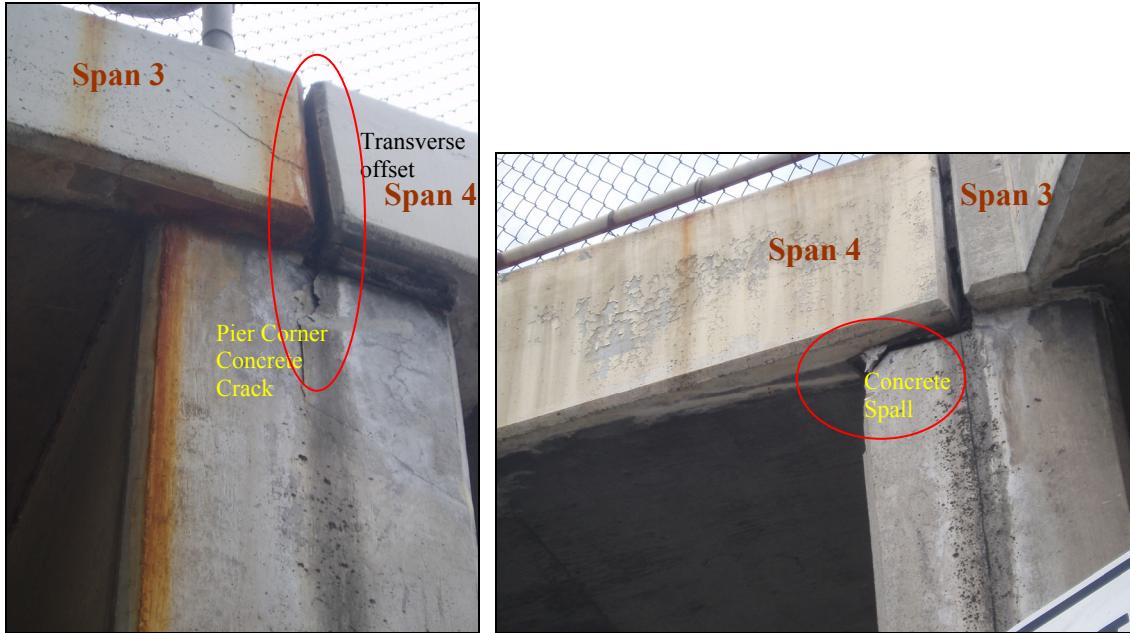
Concrete spalls and cracks were observed at the top of the piers supporting the Span 4 slab. Small pieces of concrete (triangular shapes) had fallen off and cracks were visible at the exterior face of Pier 4. Similar to Pier 5, the slab in Span 4 had a permanent offset, displacing transversely (toward the Southeast direction) at Pier 4.

The ground motion pushed the Span 4 slab transversely, bent the dowels, and induced transverse displacement on Span 4 (Figure 7). The major observed failures were bending of the dowel bars connecting the super structure slab with the pier, and concrete cracking and spalling at the corners of the piers supporting Span 4.

Figure 7 Concrete cracking and spalling at Pier 4 under Span 4.
